**DELAWARE RIVER BASIN
LOWER BIRCHWOOD LAKE DAM**

NDI NO. PA-00403
DER NO. 52-145

**PHASE I INSPECTION REPORT
NATIONAL DAM INSPECTION PROGRAM**

BY
Berger Associates, Inc.
Harrisburg, Pennsylvania
JUNE 1980

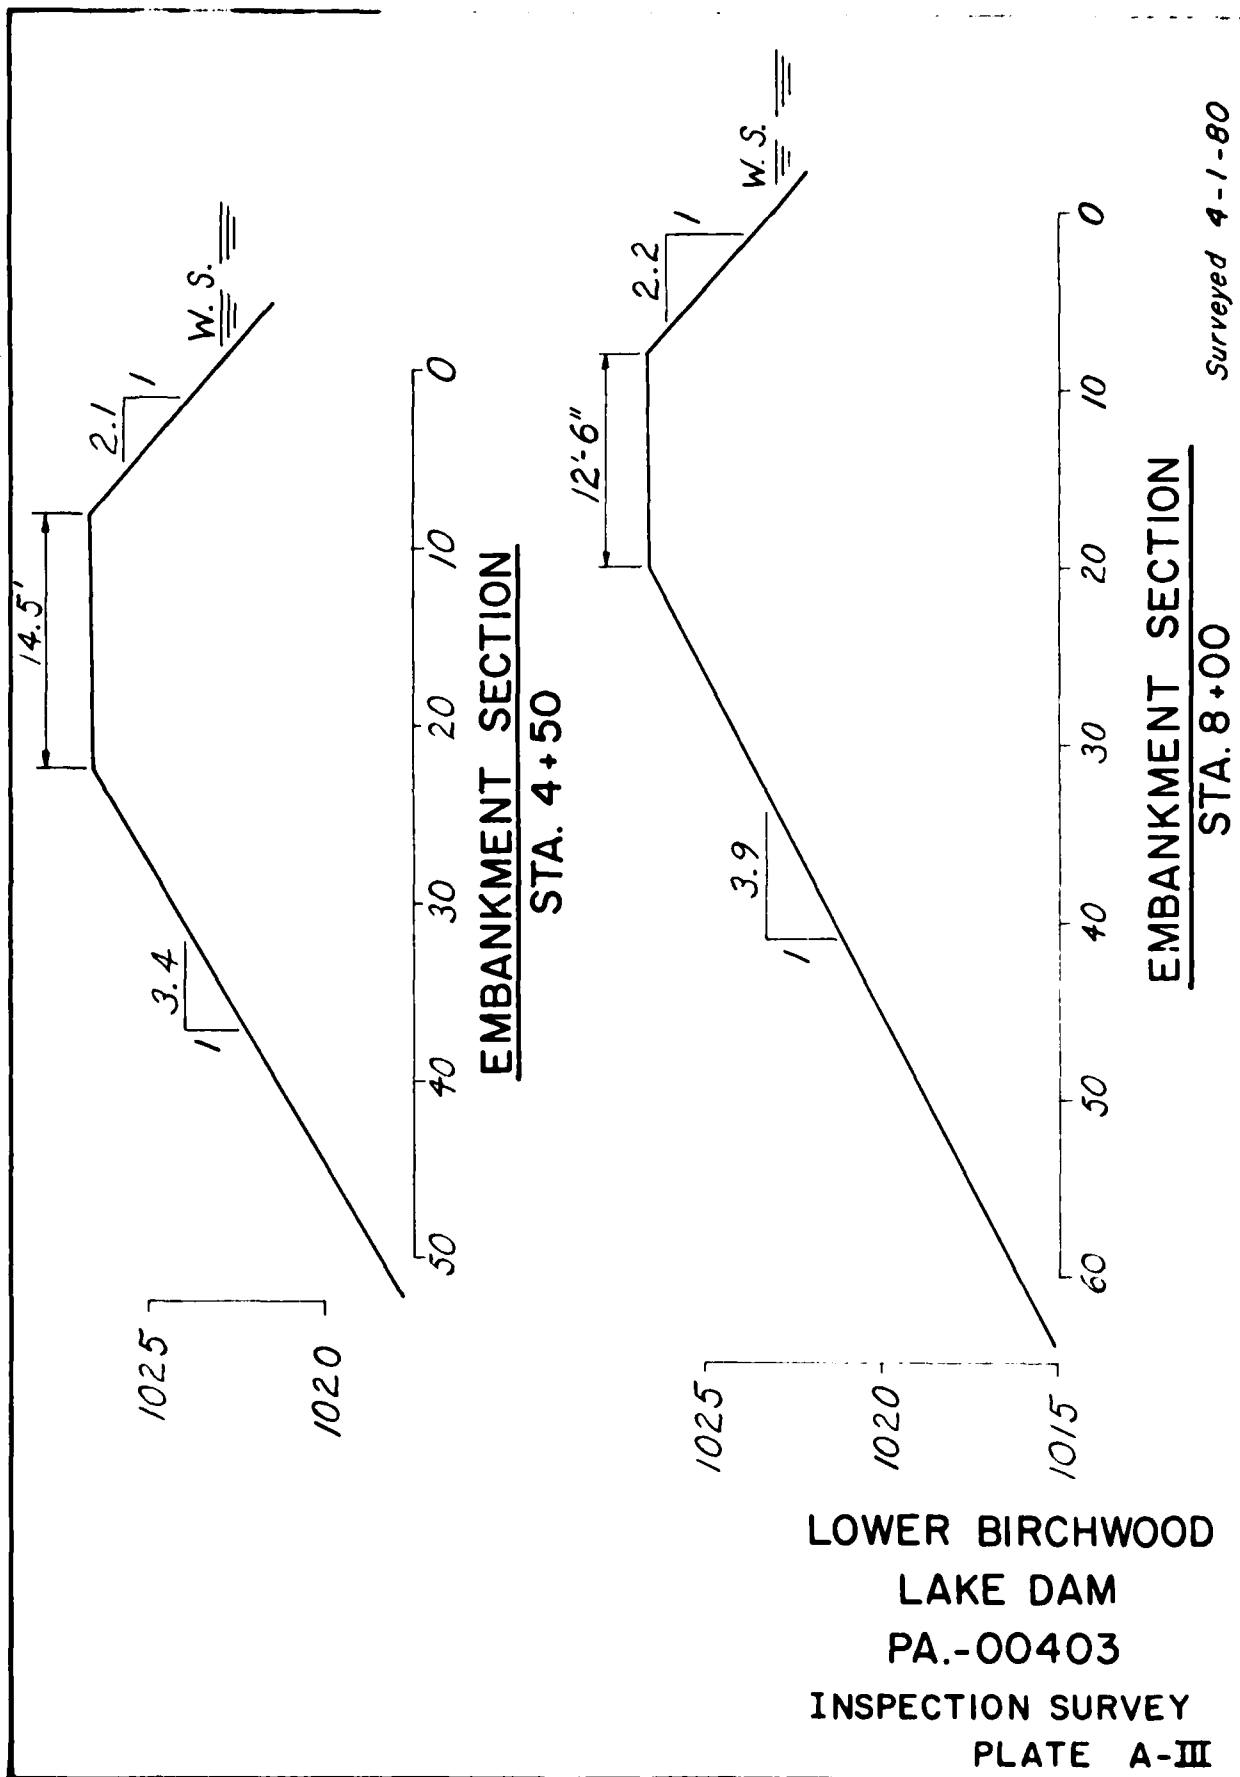
**LOWER BIRCHWOOD
LAKE DAM
PA.- 00403
INSPECTION SURVEY
PLATE A-II**

The general appearance of the Lower Birchwood Lake Dam is fair. The embankment slopes appear to be stable and adequate. Brush and trees are however present on the upstream side of the embankment over its full length and on the right end of the downstream slope. The condition of the spillway appears to be good. Flashboards have been installed on the spillway crest and apparently have been there for many years. Several wet areas were noticed along the downstream toe of the dam. The reservoir was created as a recreational attraction for a large residential development around the lake. The reservoir is located downstream of three other small reservoirs in the same development. Mr. Hugh McGrane represented the owners and accompanied the inspectors. The visual inspection check list is in Appendix A of this report. Sketches of a general plan, profile and typical cross sections as surveyed during the inspection are presented in Appendix A as Plates A-I, A-II and A-III.
